The August 24, 2016, Amatrice earthquake (Mw 6.0): field evidence of on-fault effects

PRELIMINARY REPORT

September 16, 2016

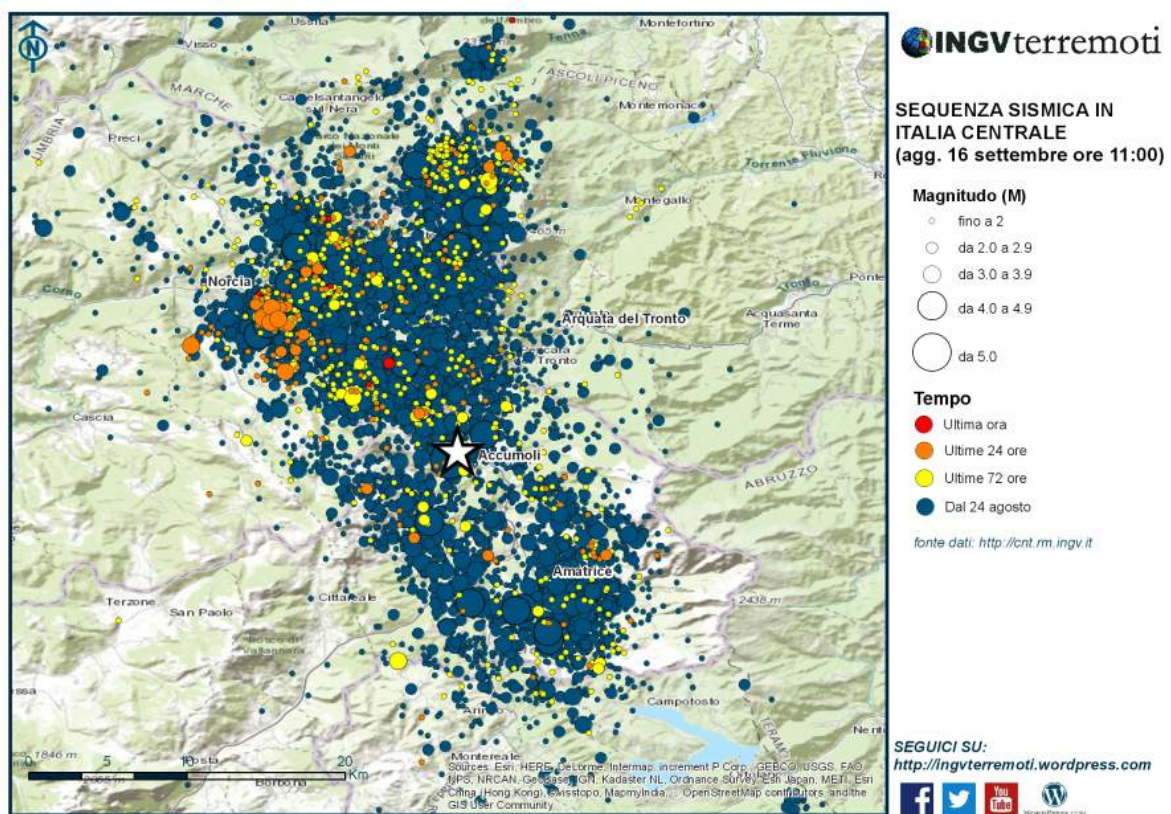
Fig. 1 – The seismic sequence started on 24 August in the Rieti, Ascoli and Perugia provinces (updated 16 September 2016). Source: INGV

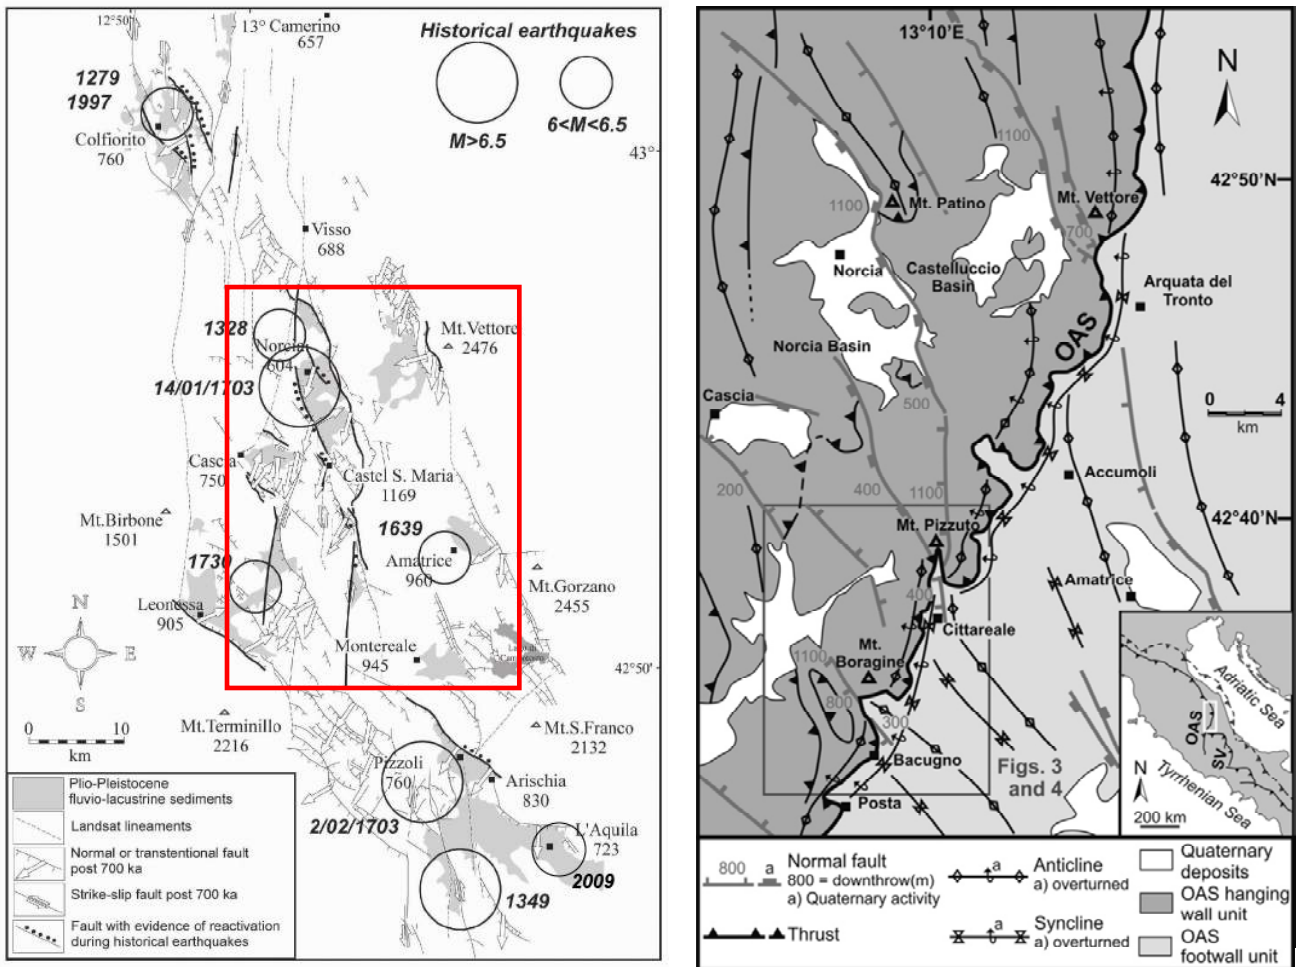
Fig. 2 – Examples of structural maps of the epicentral and surrounding areas. Left: Modified after Cello et al. (1997); Right: Di Domenica et al. (2012) (Location framed by the red box on left side figure).

This region hosts several major Quaternary normal faults with common seismic behaviour and arranged in a rather homogeneous structural pattern, which can be traced along the axis of the whole Apennines (e.g., Blumetti et al., 1993; Calamita et al., 1994; Blumetti, 1995; Piccardi et al., 1997; Cello et al., 1997; Piccardi et al., 1999; Di Domenico et al., 2012; Faure Walker et al. 2012) (Fig. 2).

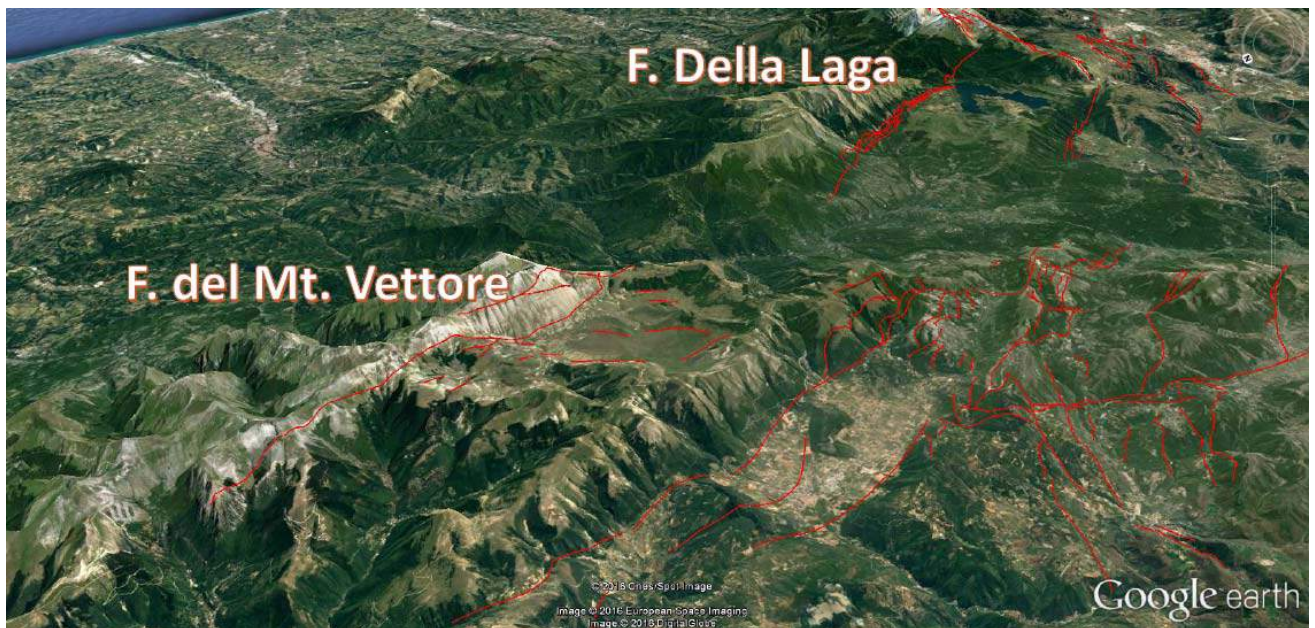
Fig. 3 – Capable faults in the epicentral and surrounding areas, according to ITHACA (source: ISPRA). View from northwest.

Also the normal faults bordering the Laga Mt., the Vettore Mt., the Norcia basin and nearby Quaternary intermountain basins are well known as capable of producing surface faulting (e.g., Blumetti et al., 1993; Blumetti, 1995), and for this reason they are included in the ITHACA database, that is, the inventory of capable faults in Italy managed by ISPRA (Fig. 3).

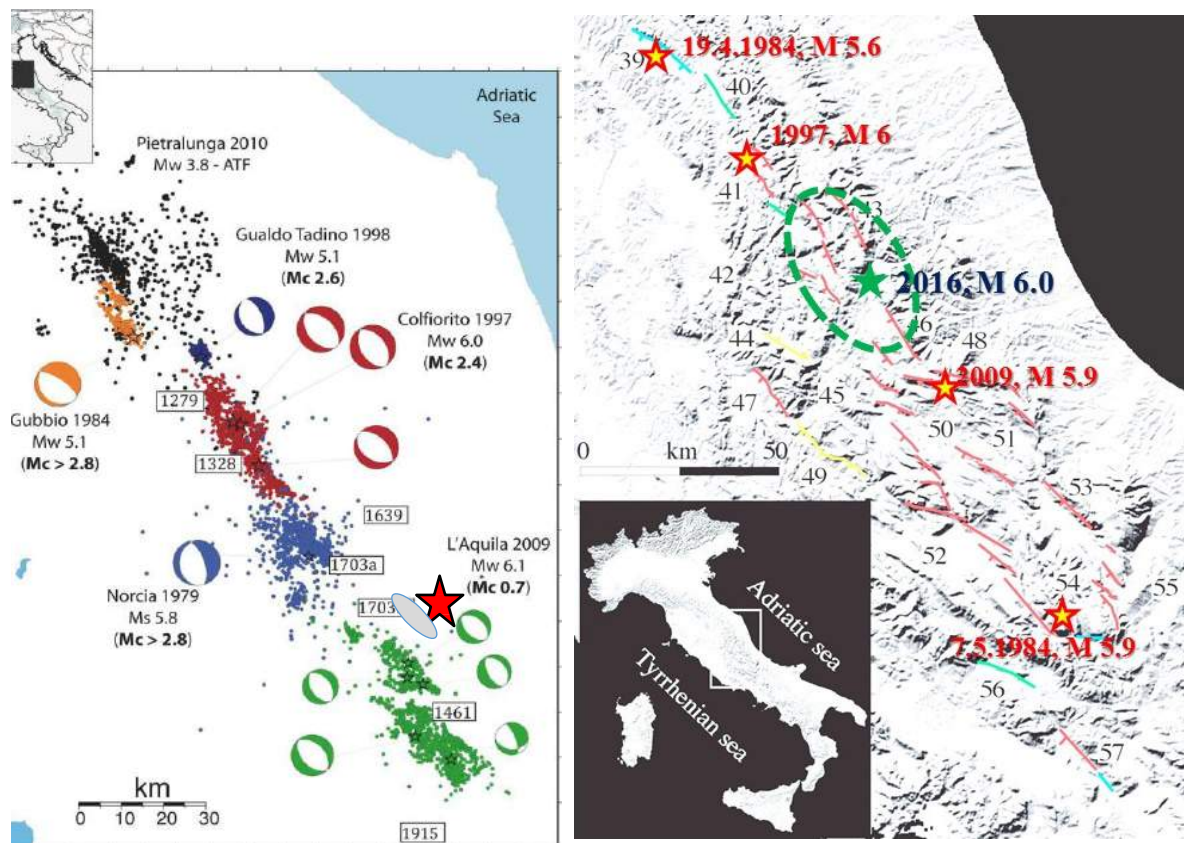
Fig. 4 - The 2016 Amatrice earthquake occurred in a seismic gap (*sensu lato*) along the inner sector of the Apenninic belt, in between the epicentral areas of 1997 Colfiorito and 2009 L'Aquila earthquakes (Gruppo di Lavoro INGV sul terremoto di Amatrice, 2016).

During the last decades, in a large sector of this system different structures periodically activated (e.g., 1979 Norcia, 1997 Colfiorito, 2009 L'Aquila), so that the present seismic crisis fills at least in part what could be seen as a seismic gap (*sensu lato*) in the region (Fig. 4).

Given the series of events with roughly decadal inter-event times that have hit the region between Gubbio and high Sangro valley since 1984 along the Apennine fault system (Fig. 4), the Amatrice, 2016, earthquake was somehow expected to eventually fill the gap between the 1997 Colfiorito and the 2009 L'Aquila earthquakes. A similar "gap" may exist for the area south of L'Aquila, between the 1984 and the 2009 earthquakes (Fig. 4, right).

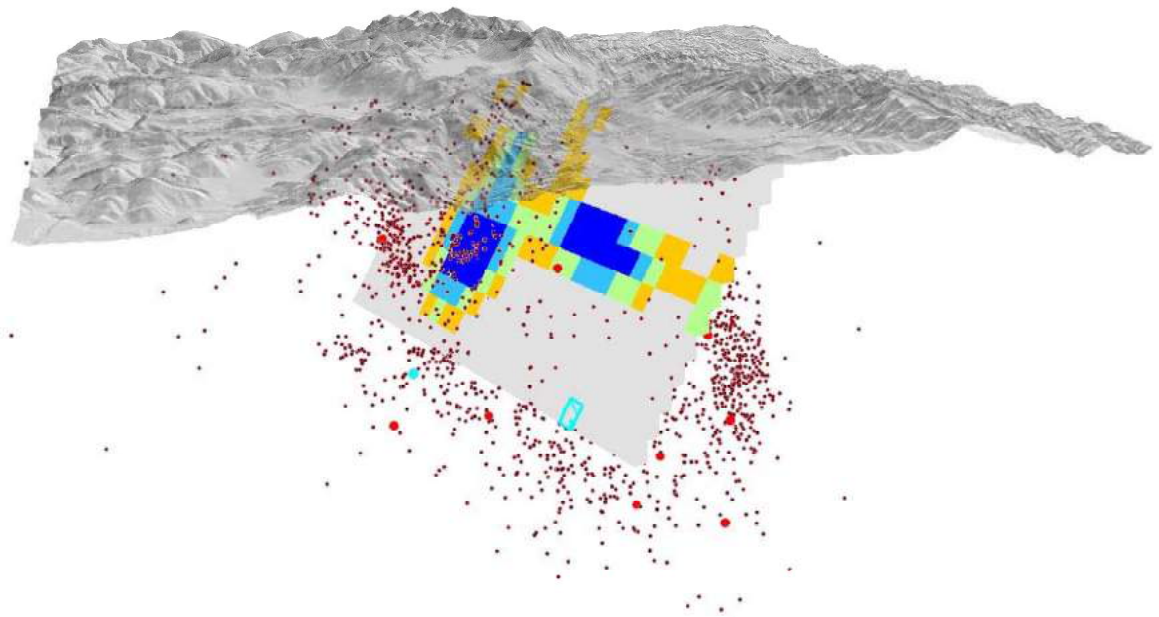
Fig. 5 - Preliminary 3D view of the seismogenic fault obtained by inversion of the static ground displacement (2 datasets SAR and 3 CGPS; Gruppo di Lavoro INGV sul terremoto di Amatrice, 2016).

The preliminary model of the coseismic slip distribution (data ALOS2, Sentinel 1 and continuous GPS) and fault model from inversion of ground displacement (2 dataset SAR and 3 CGPS) has shown that most slip on the fault occurred in two areas, a deeper one beneath the Norcia and Castelluccio basins, and a shallower one (about 5 km) just under Accumoli: the maximum slip on the fault at depth, of more than 1.3 m, has been evaluated for this second area (*Gruppo di Lavoro INGV sul terremoto di Amatrice, 2016*) (Fig. 5). However, note that such studies are ongoing and the slip-distribution may be updated in the future.

Nevertheless, the affected area corresponds to the zone where, according to the model of slip distribution (Fig. 5), shallow and maximum slip occurred on the fault at depth. Looking at the distribution of capable faults mapped in ITHACA database (Fig. 28), we can observe that the surveyed area is located on the northern extension of the Amatrice fault segment (northwestern tip between San Lorenzo e Flaviano and Accumoli) toward the Mt. Vettore fault (southeastern tip near Arquata del Tronto).

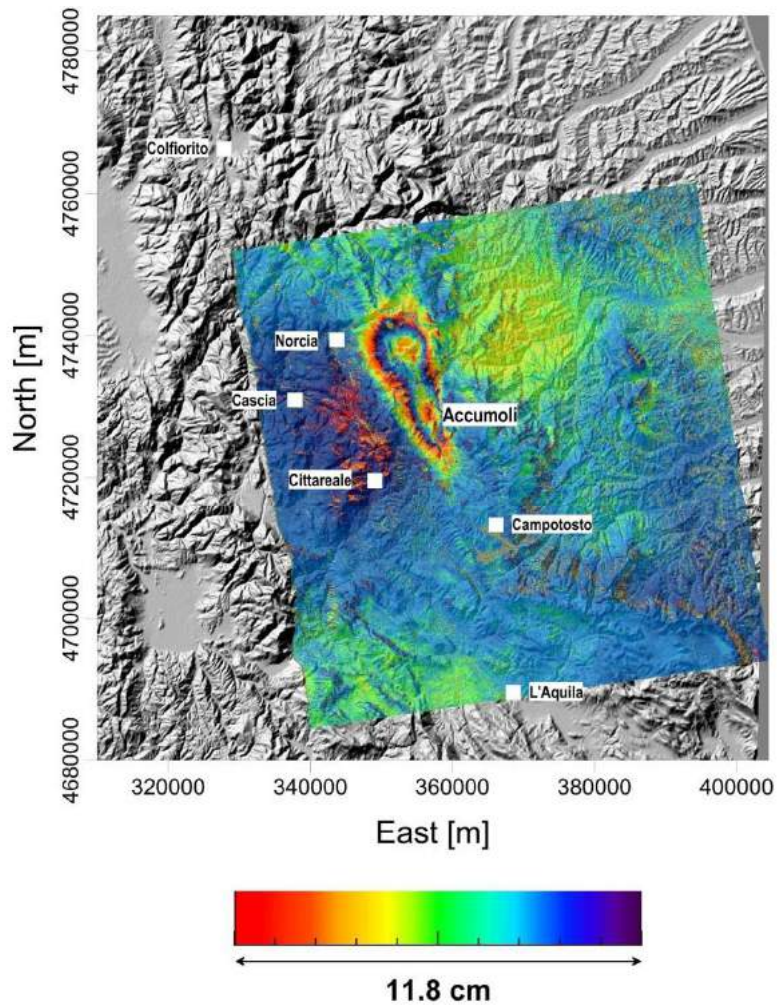
Fig. 6 - Differential interferogram obtained by the pair of ALOS-2 acquisitions, covering the time interval 2015/09/09 – 2016/08/24 (Gruppo di lavoro IREA-CNR & INGV, 2016).

The differential interferogram used for the inversion is shown in Fig. 6. It derives from a pair of ALOS-2 images covering the period 2015/09/09 – 2016/08/24.

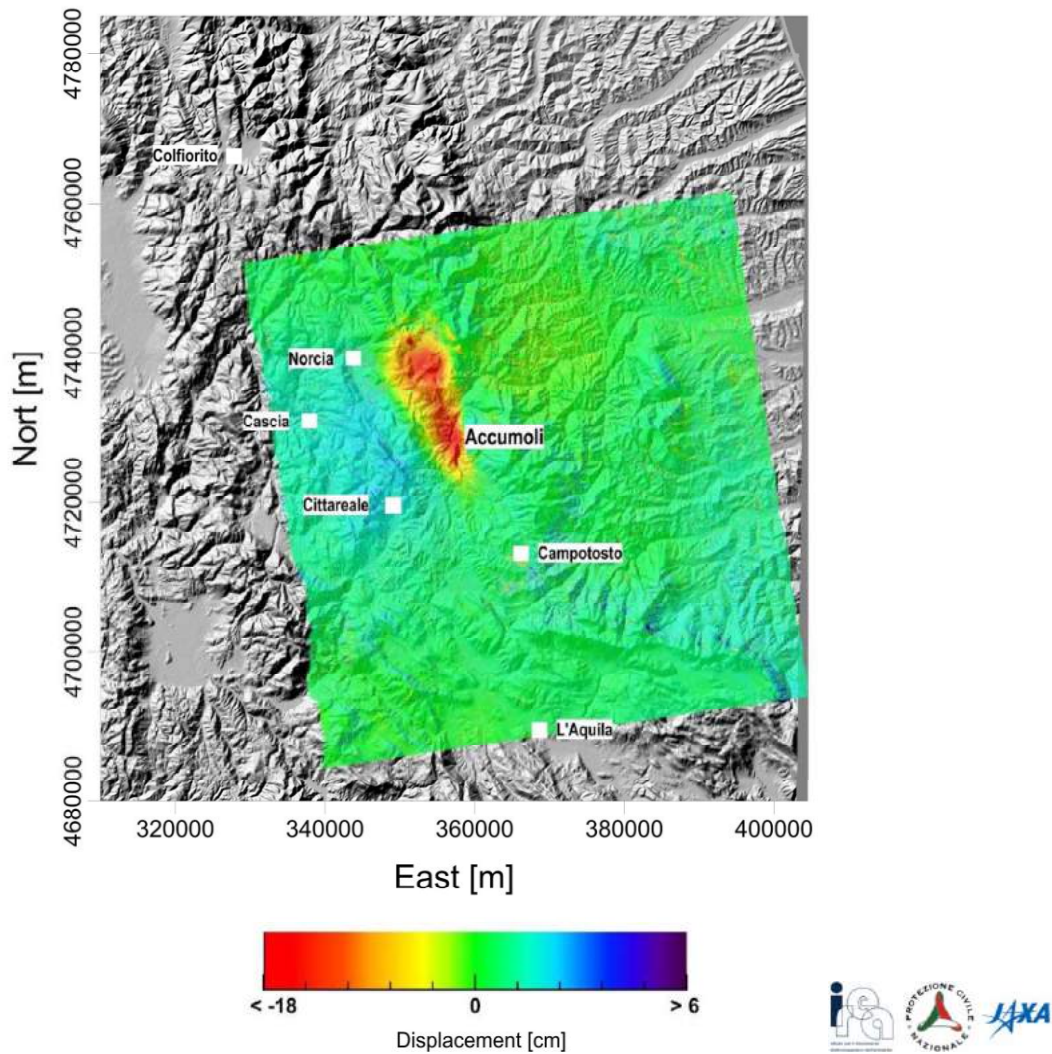
Fig. 7 shows the ground deformation along the Line of Sight (LOS) in centimeters. The maximum lowering of about 20 cm was recorded in the Accumoli area. Northward, another wider depression, up to 18 cm deep, was perhaps generated by the M 5.3 aftershock.

Fig. 7 - LOS ground motion map derived from the differential interferogram of Fig. 6 (Gruppo di lavoro IREA-CNR & ING V, 2016)

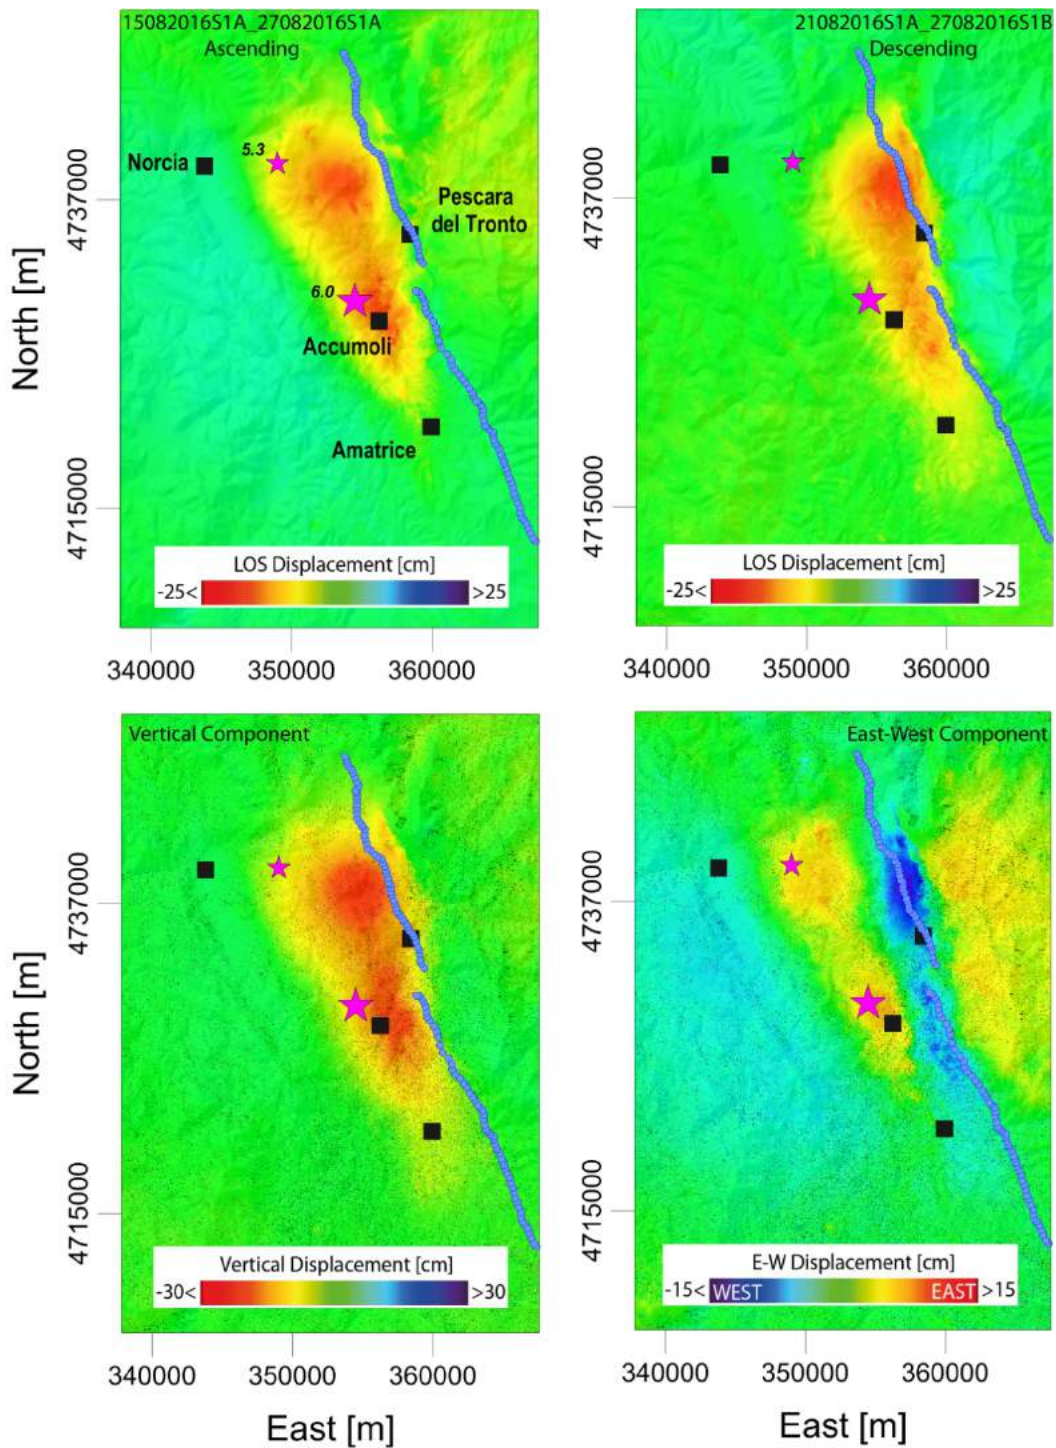
Fig. 8 - Upper part: Ascending and descending mode InSAR ground motion maps of the Sentinel 1A and Sentinel 1B images (along the LOS) related to the august 15 and 21, 2016 (before the event) and august 27, 2016 (after the event); Lower part: Vertical and E-W component of the ground motion derived from joined ascending and descending LOS images. In blue the interpreted fault trace on the surface (http://www.irea.cnr.it/index.php?option=com_k2&view=item&id=755:terremoto-di-amatrice).

Data from Sentinel-1A and Sentinel-1B (operating in C band) and from COSMO-Sky-Med (operating in X band) acquired before (August 15) and after (August 27) the event have been studied by IREA-CNR and ING V (in collaboration with ASI). Fig. 8 shows the LOS, in ascending and descending mode, coseismic ground deformation maps (Figure 7) and the vertical component and east-west component of the ground motion (below). The results confirm a “spoon-shaped” lowering of the ground with a maximum sinking of 20 cm in the Accumoli area. Moreover, the E-W component of motion affects a wider area than does the vertical component, with a maximum deformation of 16 cm towards the west. The fault trace at surface based on the interpretation of these data is marked in blue (but with no more specific explanation).

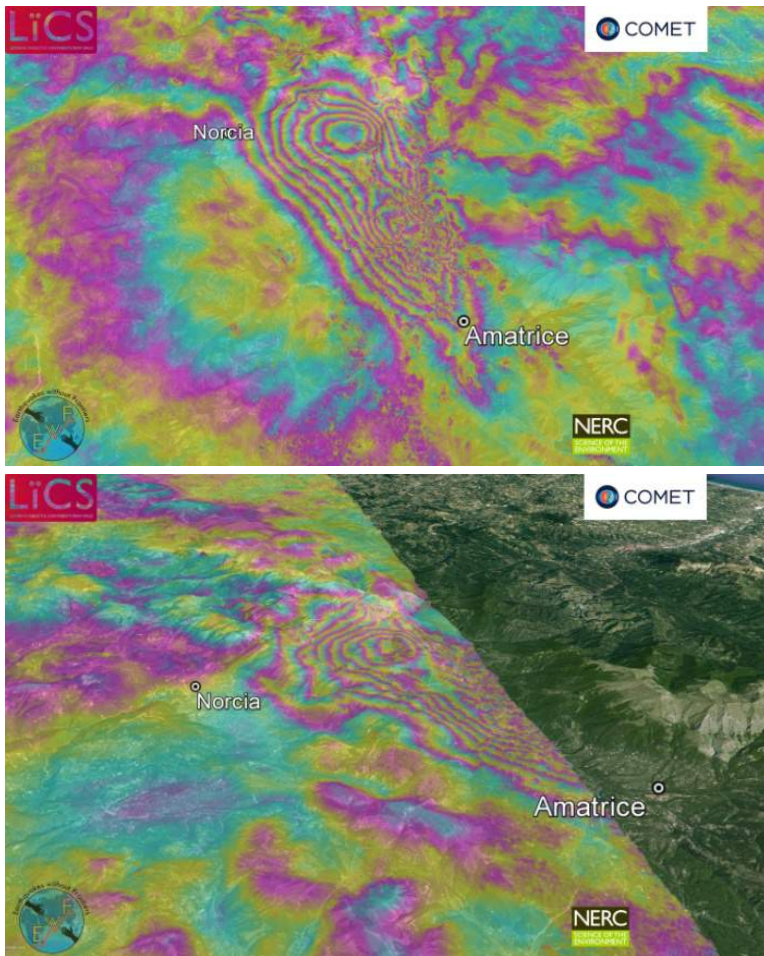
Fig. 9 - Interferograms of ascending (above) and descending (below) Sentinel-1 data (<http://comet.nerc.ac.uk/>)

Sentinel 1 InSAR images were processed also by COMET (NERC): the ascending (left side) and descending (right side) interferograms are shown in Fig. 9.

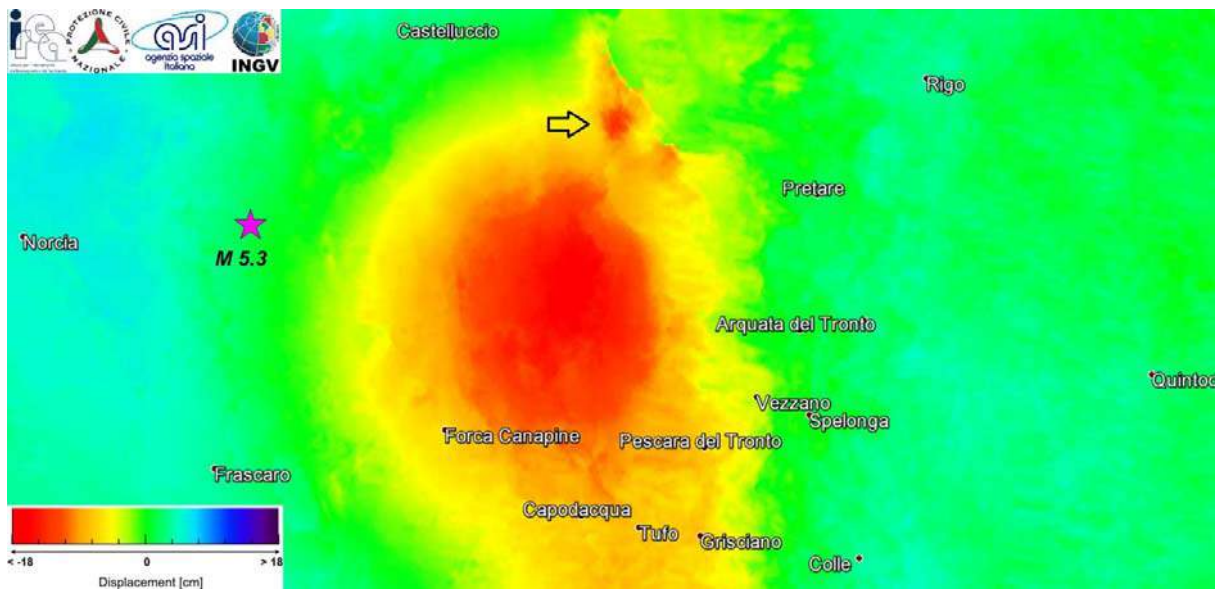
Fig. 10 - Coseismic ground deformation map obtained from InSAR analysis of COSMO-Sky-Med images (ASI) acquired along a descending orbit on August 20, 2016 (before the event) and on August 28, 2016 (after the event). The arrow indicates the deformation along the slope of Vettore Mt, suggested to be due the sliding of the slope debris cover (http://www.irea.cnr.it/index.php?option=com_k2&view=item&id=755:terremoto-di-amatrice).

High resolution COSMO-Sky-Med images (X band) were studied by INGV and CNR-IREA. The InSAR coseismic deformation map is shown in Fig. 10: the deformation along the western slope of the Mt. Vettore (indicated by an arrow) has been interpreted as the result of a minor gravitational mass movement by those authors.

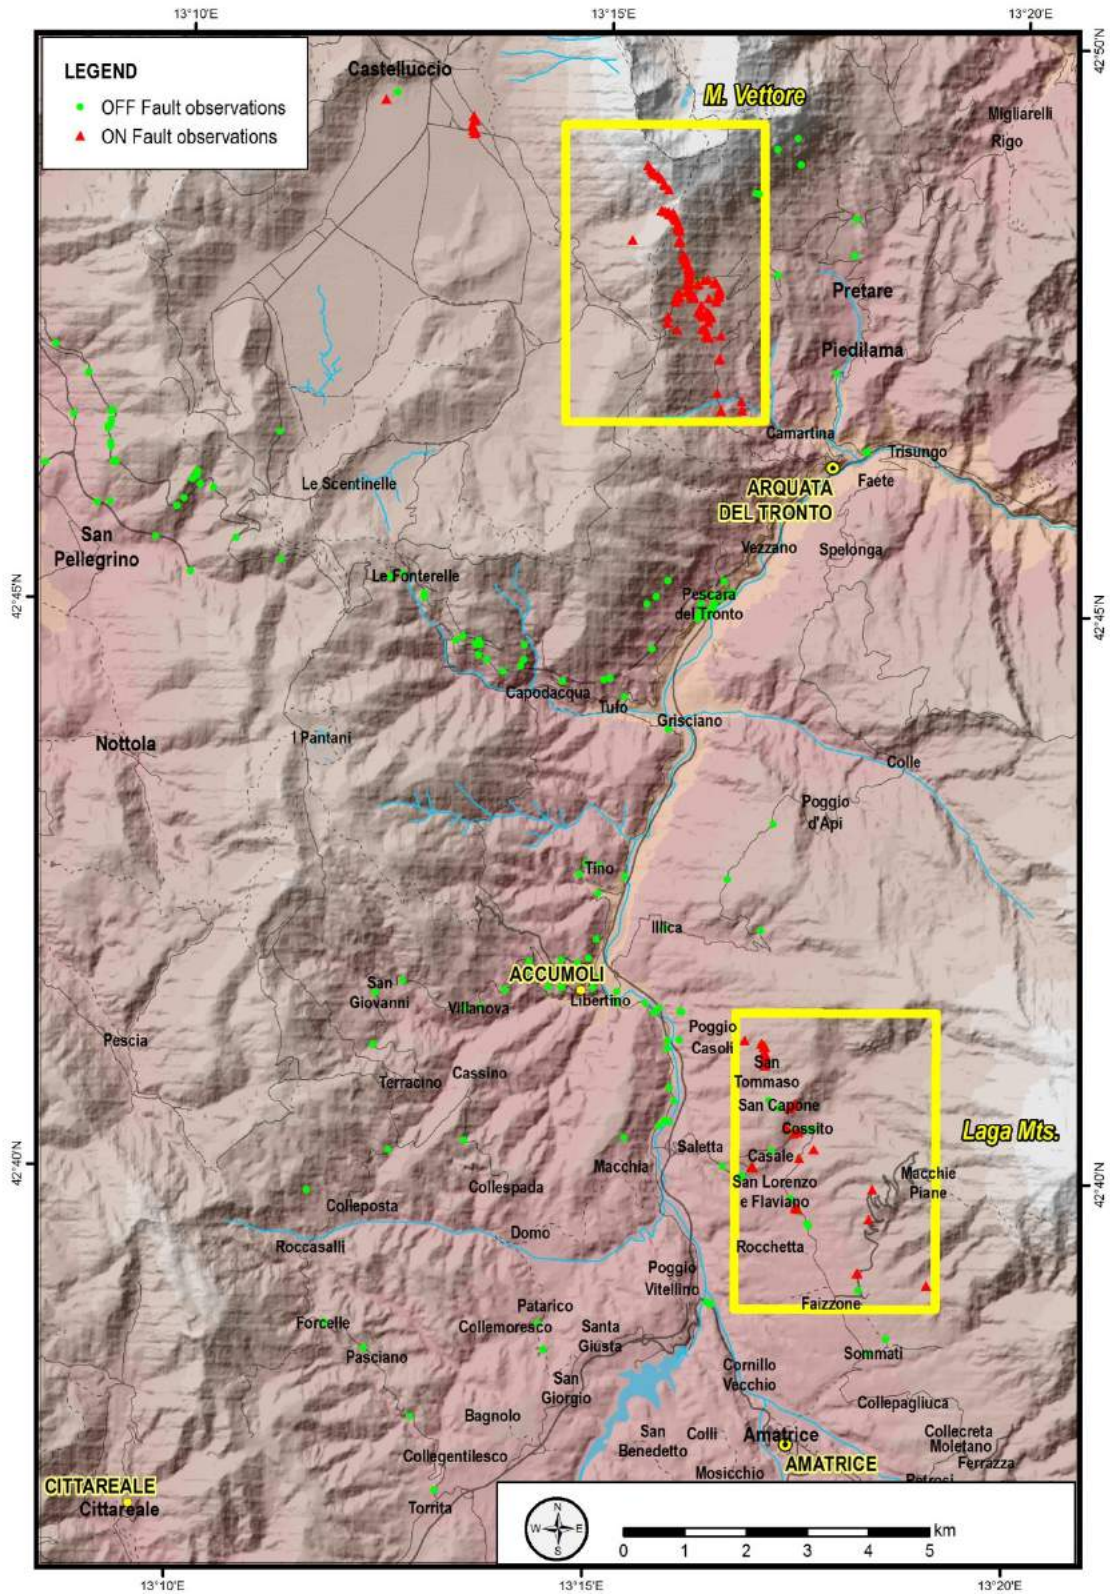
Fig. 11 – The two areas (in yellow) where field surveys of on-fault effects (red points have been performed. Green points are referred to off-fault observations (e.g. secondary effects) that are out of the scope of this report.

As indicated by the aftershocks distribution and interferometric data (see previous chapter) and in accordance with geological knowledge, the seismic source of this earthquake is organized in two main fault segments, separated by a right-step in the area of the epicentre (Pescara del Tronto, Grisciano), which correspond at surface to the Mt. Vettore fault (north) and to the northern portion of the Laga fault (namely the Amatrice fault, south). Figure 11 shows the two areas of on-fault field surveys along the Mt. Vettore fault and the Laga fault (up to September 3). More detailed maps are found in Figs. 14 and 22.

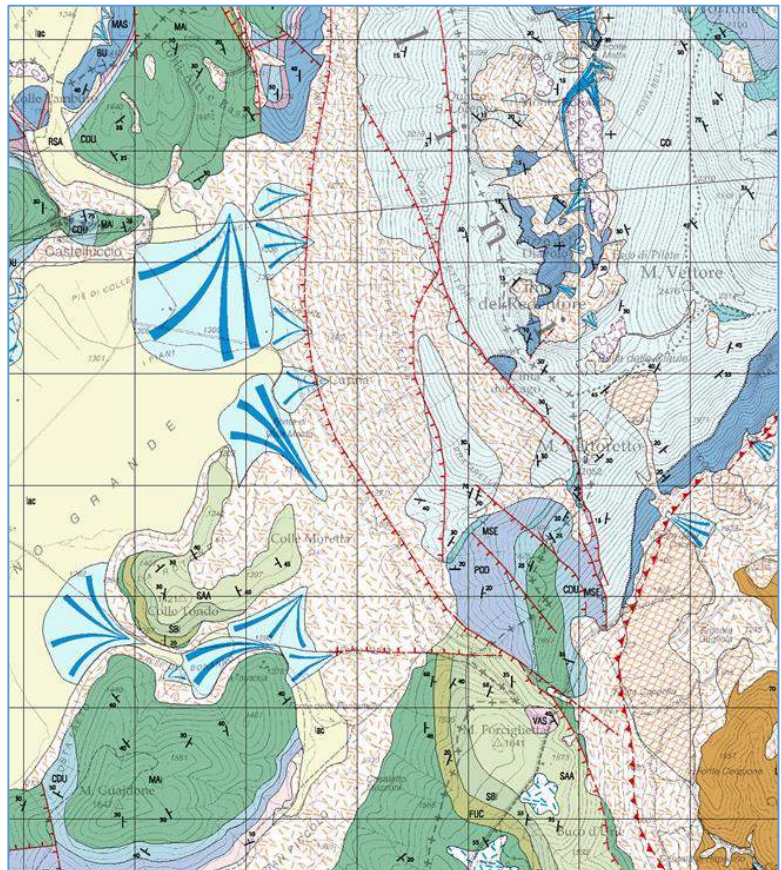
Fig. 12 – Geological map of the western slope of Mt. Vettore (source: Pierantoni et al., 2013).

The western slope of Mt. Vettore is the morphologic expression of a NNW-SSE trending SW dipping primary extensional tectonic element (total length 30 km) with northern termination at Mt. Bove. The total stratigraphic offset is in the order of one thousand meters. The slope is marked by at least two major normal faults: the lower fault runs at the base of the Vettore escarpment and bounds the Castelluccio basin. The upper fault runs very close to the top of the Mt. Redentore, marked by a clearly visible fault scarplet in bedrock (commonly named “*Cordone del Vettore*”). A recent geological map (Pierantoni et al., 2013) provides a detailed trace of these faults (Fig. 12).

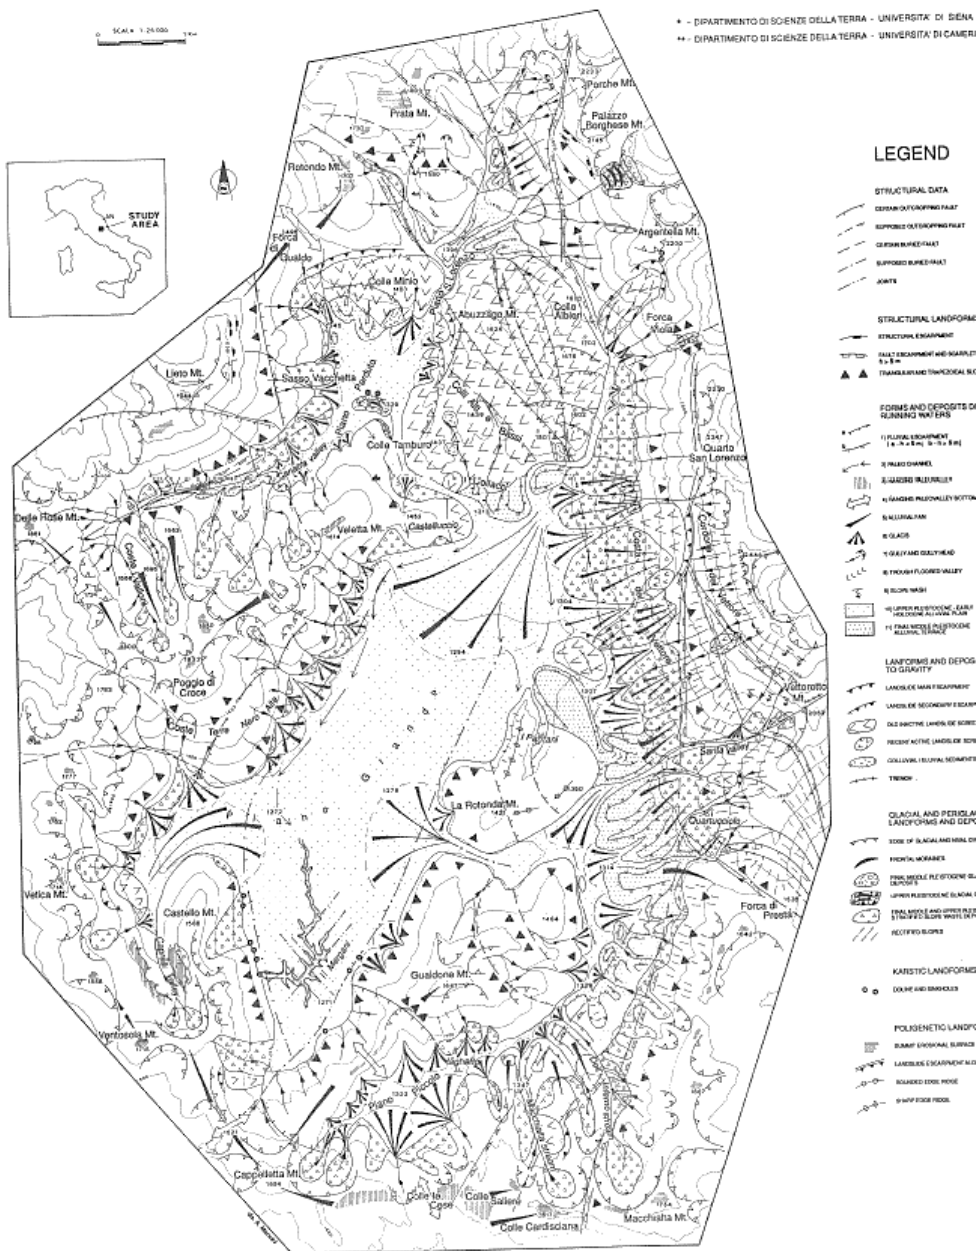
GEOMORPHOLOGICAL MAP OF THE CASTELLUCCIO DI NORCIA BASIN (UMBRIA - MARCHE APENNINES, ITALY)

Fig. 13 – Geomorphological map of the Castelluccio di Norcia Basin (source: Coltorti and Farabollini, 1995).

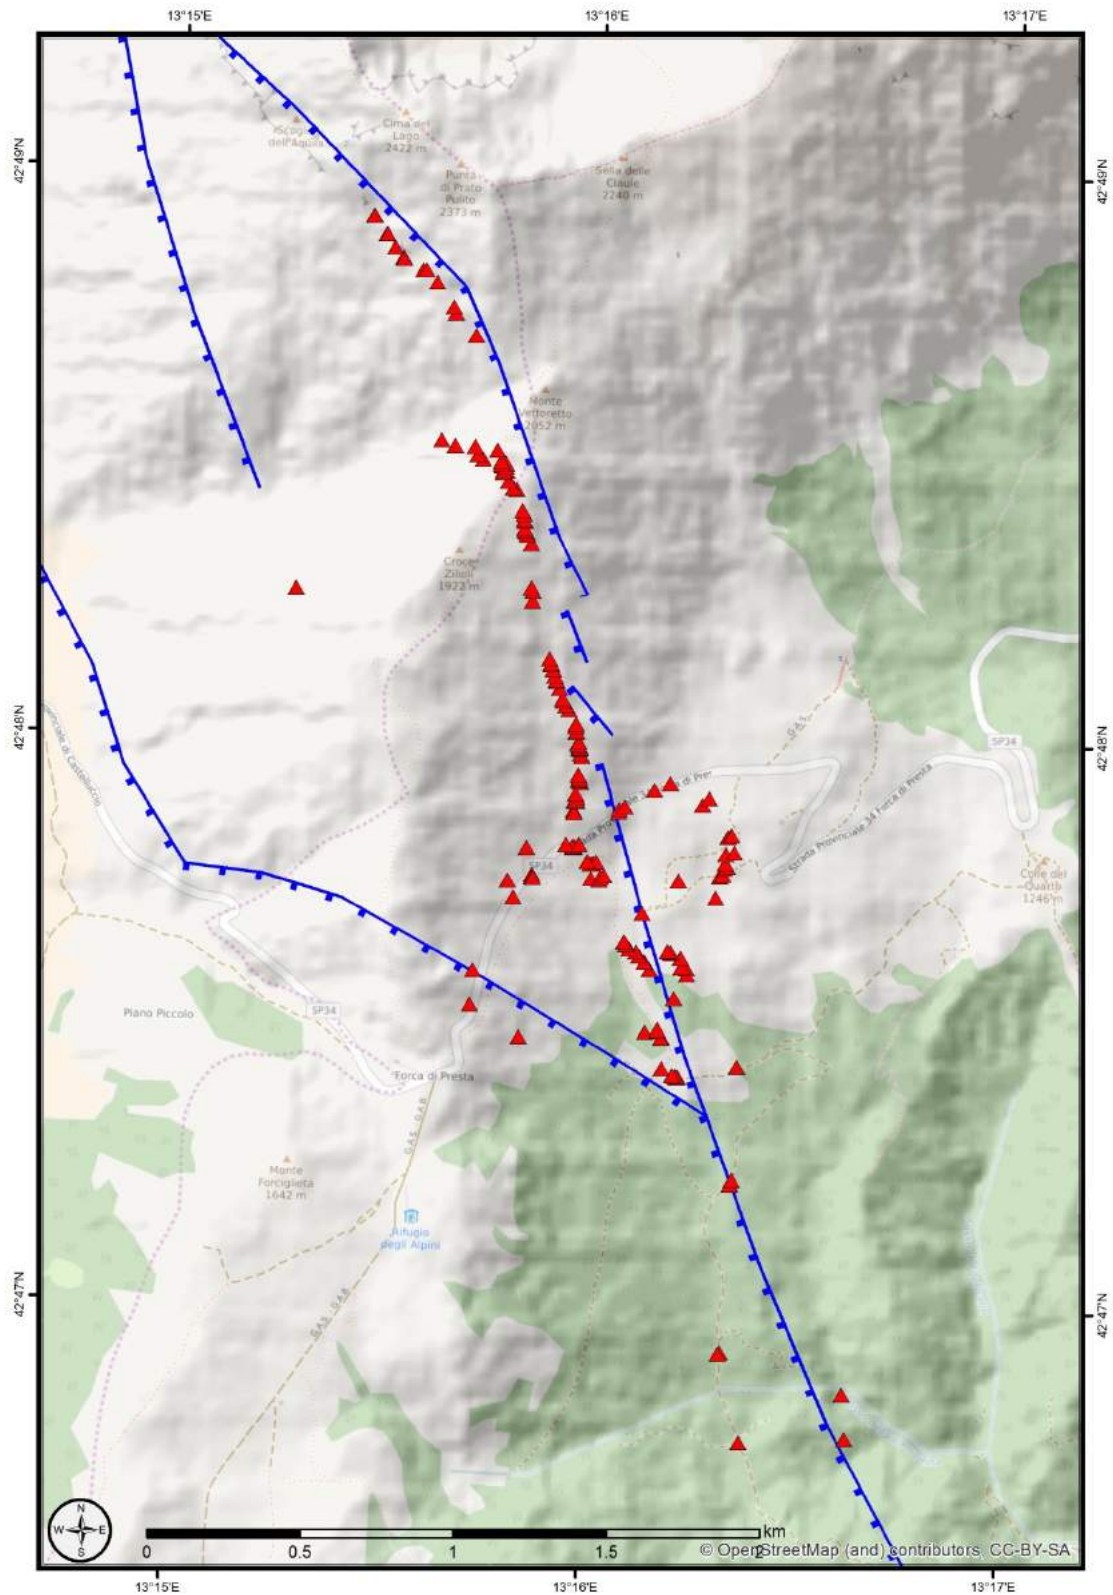
Fig. 14 – Observation points of on-fault effects along the Mt. Vettore fault.

Figure 14 shows in detail the observation points related to on-fault effects along the Mt. Vettore fault. In Fig. 15 the pattern of coseismic surface faulting along the Mt. Vettore fault based on the results of our surveys is shown in detail.

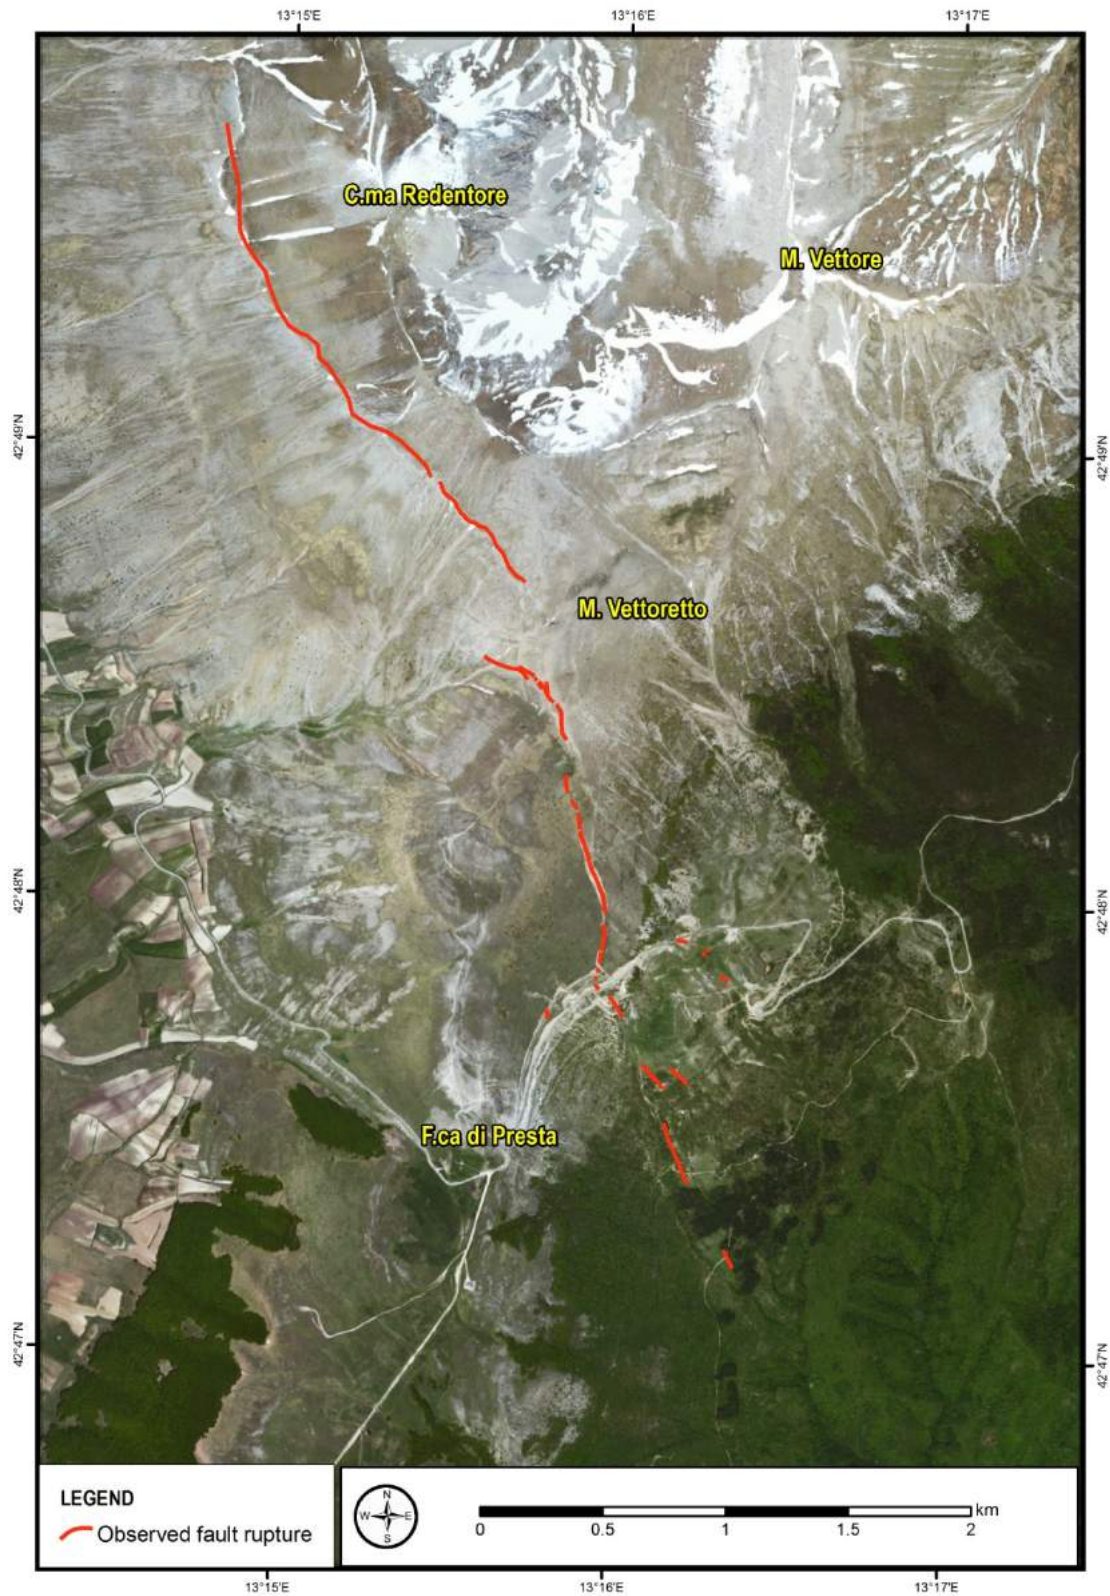
Fig. 15 – Pattern of ground ruptures observed along the Mt. Vettore fault. See text for details.

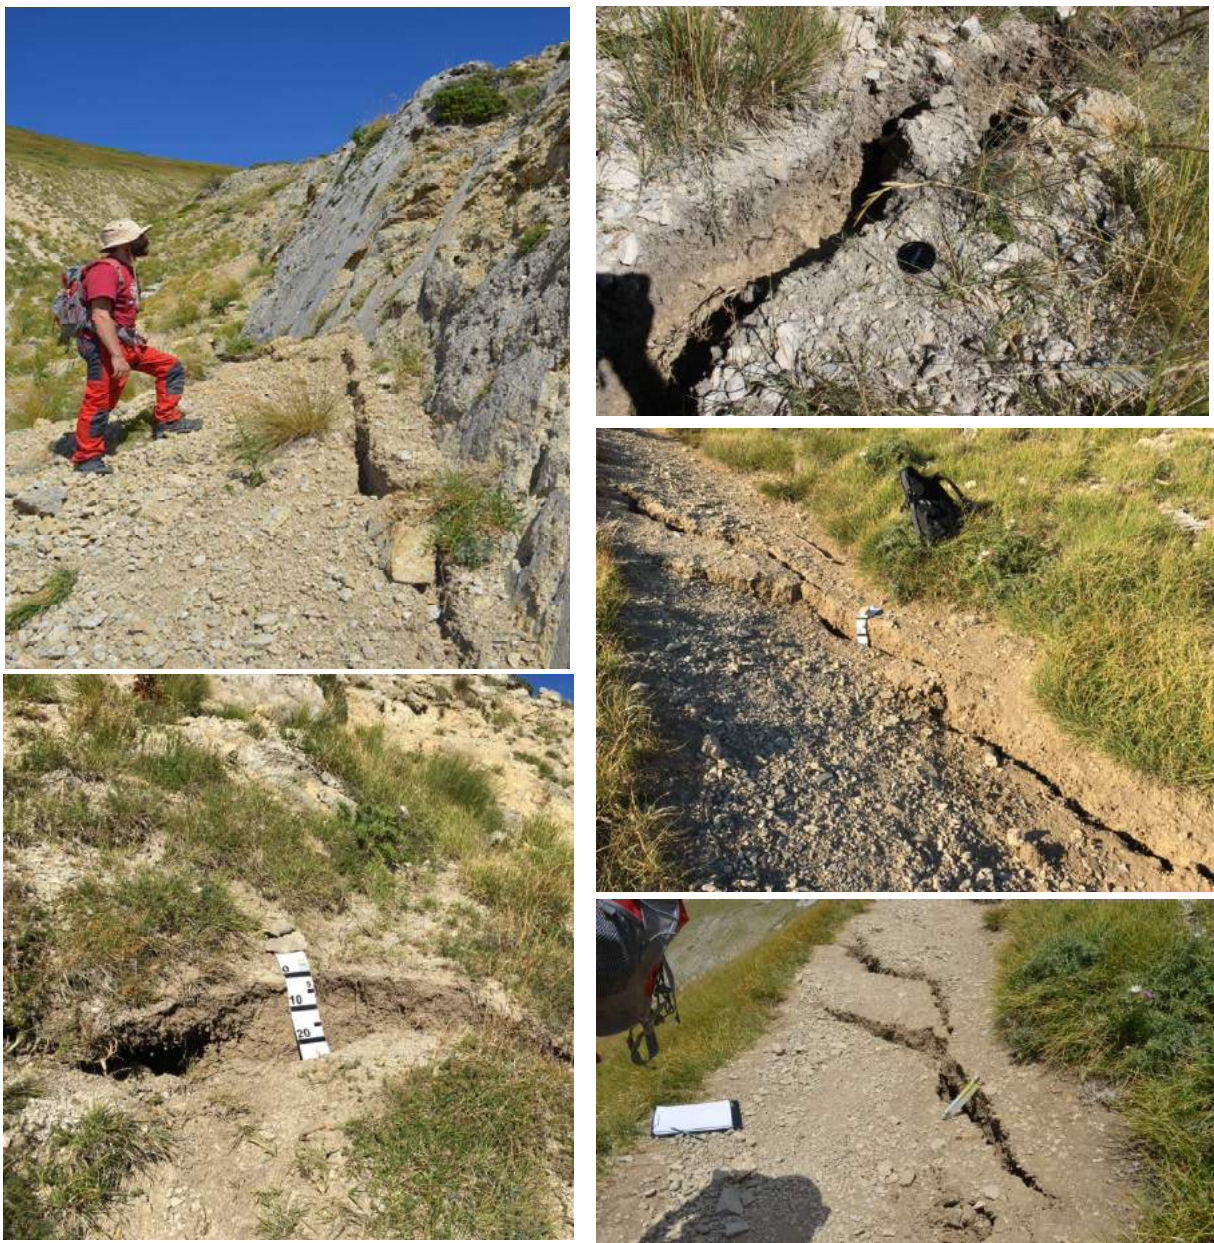
In particular, a set of very clear ground ruptures was surveyed on the southern slope of Mt. Vettore in correspondence to the Mt. Vettore fault (Fig. 16). These ruptures mainly strike between NNW-SSE, with a slight left-lateral horizontal component. They generally affect colluvium and soil, often very close to the bedrock fault plane, but sometimes at a distance of several meters. In the first days, the observed throws were ranging from 2 to 25 cm, while opening reached 10 cm (see ahead for post-seismic evolution). These ruptures can be followed almost without interruptions from the SP34 (province road) to the end of Mt. Vettore slope, where the ruptures bend downslope to a ca. WNW direction. This portion of the rupture is continuous for about 1.7 km.

Fig. 16 – The ground ruptures cropping out on the southern slope of Mt. Vettore, above the SP34.

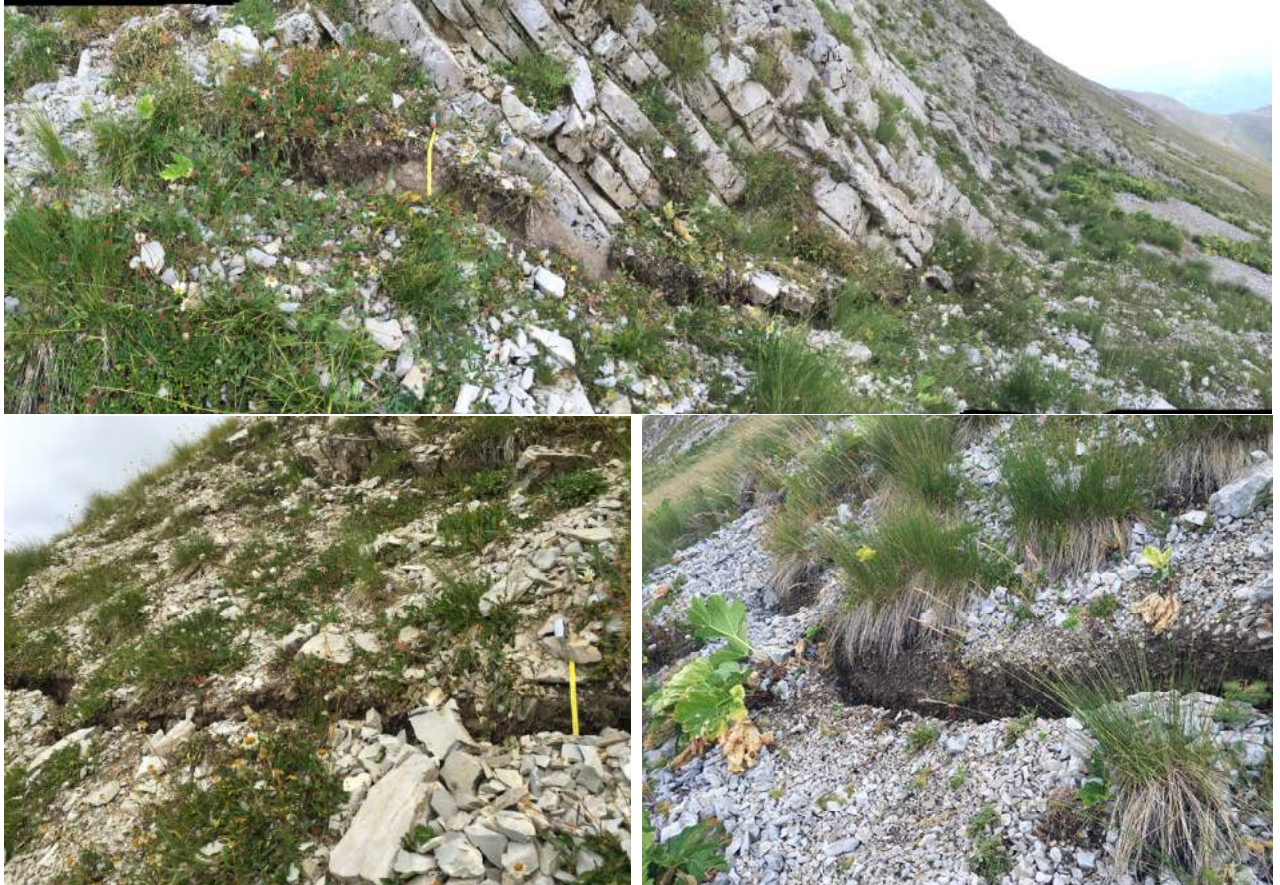
Continuing to uphill NW, even more evident ground ruptures are found in correspondence to the NW-SE trending fault segment running just below the top of Cima Redentore (namely the “Cordone del Vettore” fault). Here the ruptures (Fig. 17) have been surveyed in detail for about 2.4 km, but preliminary mapping shows that they continue northward, terminating somewhere before the end of the “cordone”. The end-to-end length of this rupture zone is in excess of 4.5 km.

Fig. 17 – The ground ruptures along the “Cordone del Vettore” fault segment.
