The August 24, 2016, Amatrice earthquake (Mw 6.0): field evidence of on-fault effects

PRELIMINARY REPORT

September 16, 2016

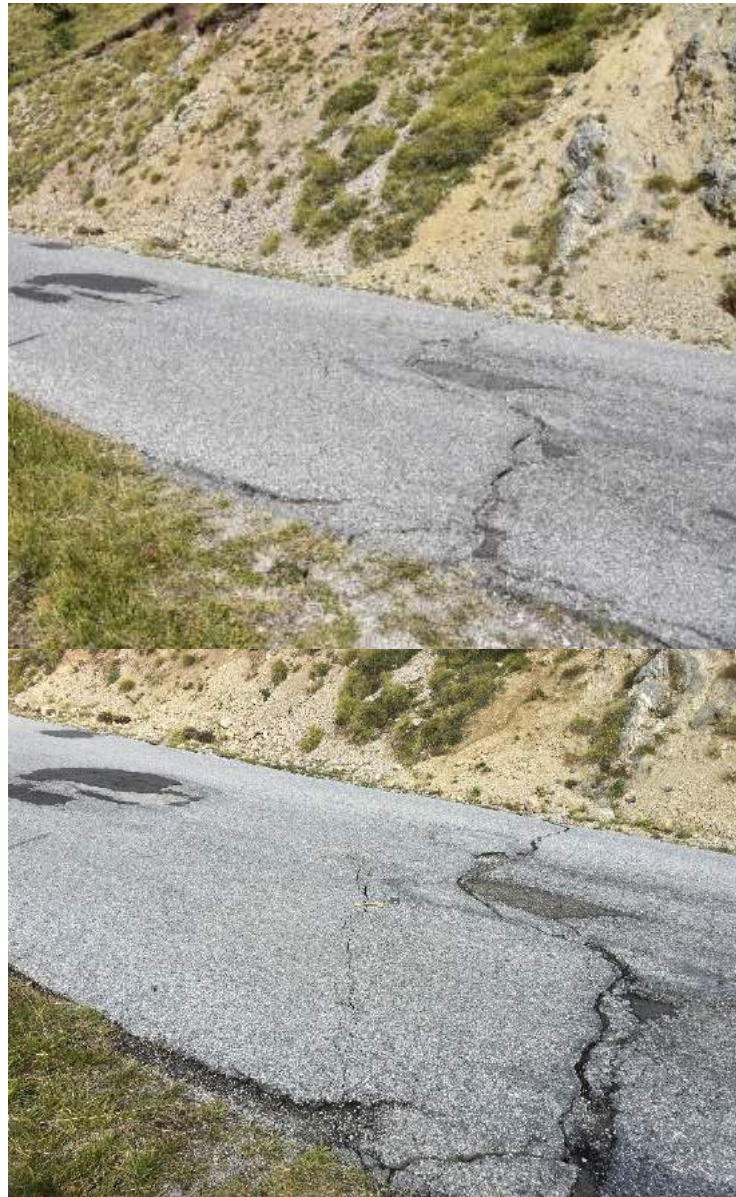
Repeated field surveys have clearly pointed out a post-seismic evolution of the rupture, whose vertical offset is continuing to increase with time. The phenomenon is clearly evident where the fault crosses the road SP34 (Fig. 19).

Fig. 19 - Evidence for afterslip at the Forca di Presta road. Above, reactivation of a pre-existing asphalt crack with virtually no displacement and a very thin new oblique crack, as observed on August 27; below, downwarping on the left side (west) and widening of the oblique crack (4 to 5 cm downthrow); new cracks have also appeared in the ground on both sides of the road (photograph taken on August 31).

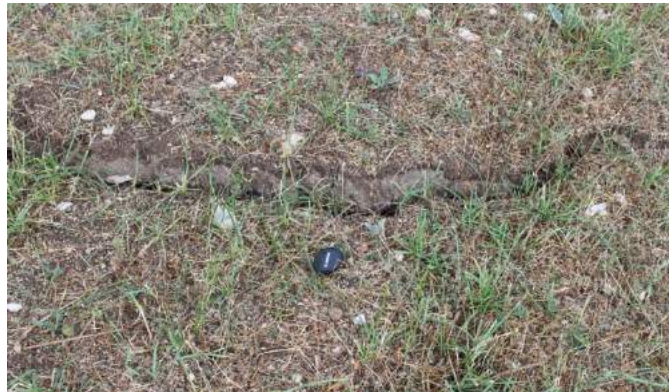
In the Castelluccio basin, a NE-SW trending ground fracture (vertical throw ≥ 10 cm, length in excess of 100 m, Fig. 20) appeared just south of the village of Castelluccio, possibly along an existing fault. If so, this might be a sympathetic rupture along an apparently secondary fault. Discontinuous cracks were also seen over a length of ca. 400 m in the plain at the foot of the Mt. Vettore, along the north-south subduced fault trace where a paleoseismological trench was excavated by Galadini and Galli (2000).

Fig. 20 – Ground rupture in correspondence to the NNE-SSW trending antithetic fault just below the village of Castelluccio.

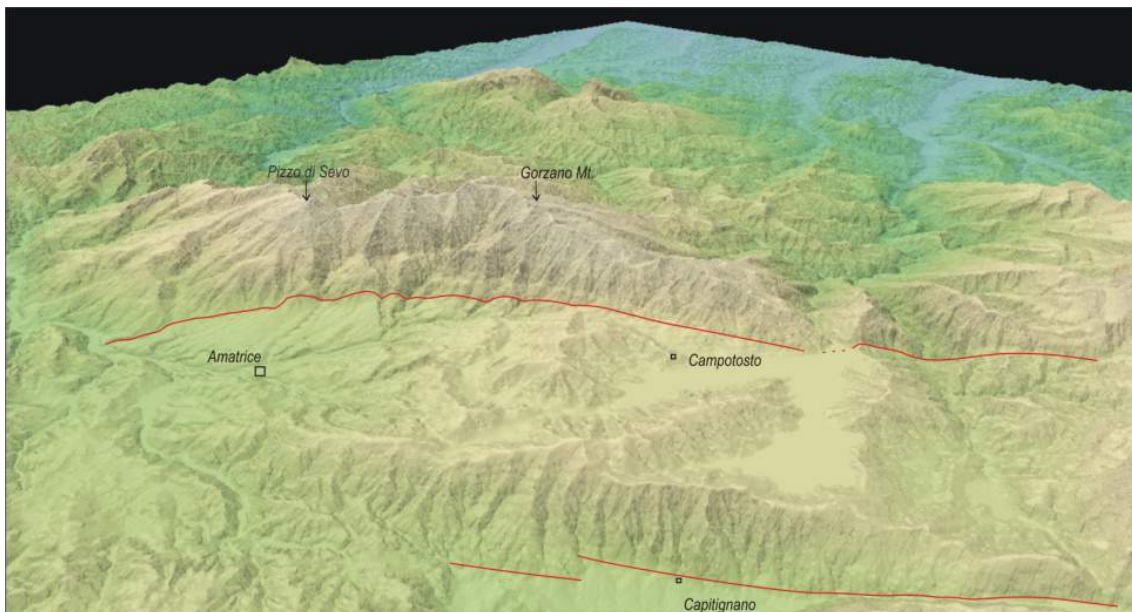
Fig. 21 – The main Laga fault and the associated Mt. Gorzano fault escarpment (source: Blumetti and Guerrieri, 2007)

The Laga fault is a N20W trending normal fault that bounds the Amatrice and Campotosto plateau and runs at the base of the Mt. Gorzano fault escarpment (Fig. 21).

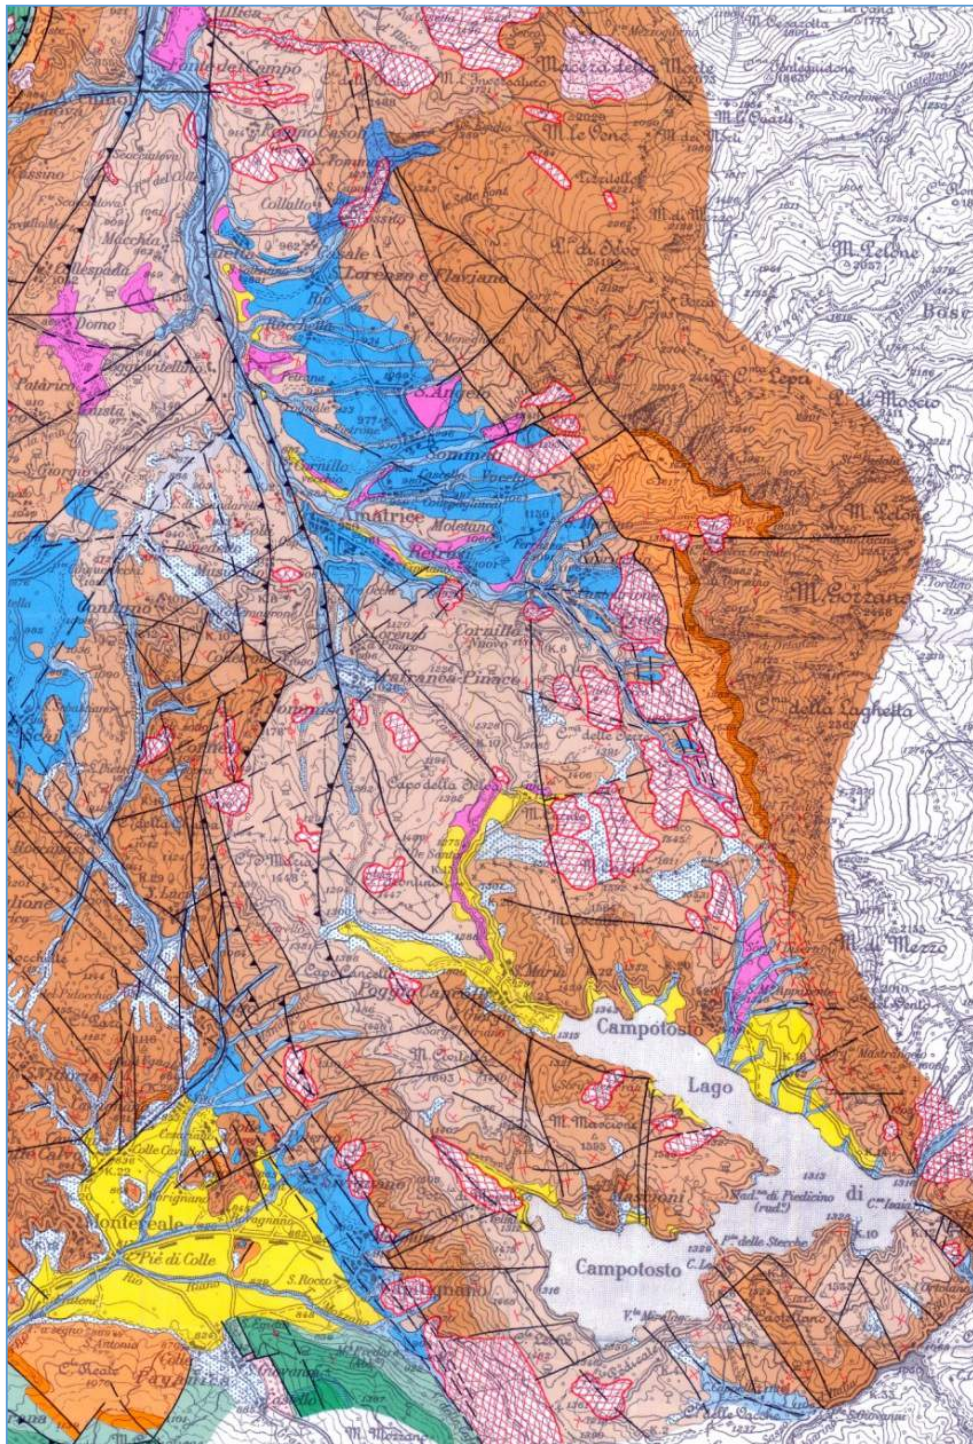
This mountain front is mainly made of arenaceous-to-clay deposits of the Laga Formation (Messinian) resting on marls (Marne a Pteropodi Fm.) and marly limestones (Marne con Cerrognà Fm.). See Fig. 22 for more details.

Fig. 22 – Geological map of the Amatrice and Campotosto plateau (source: Cacciuni et al., 1995)

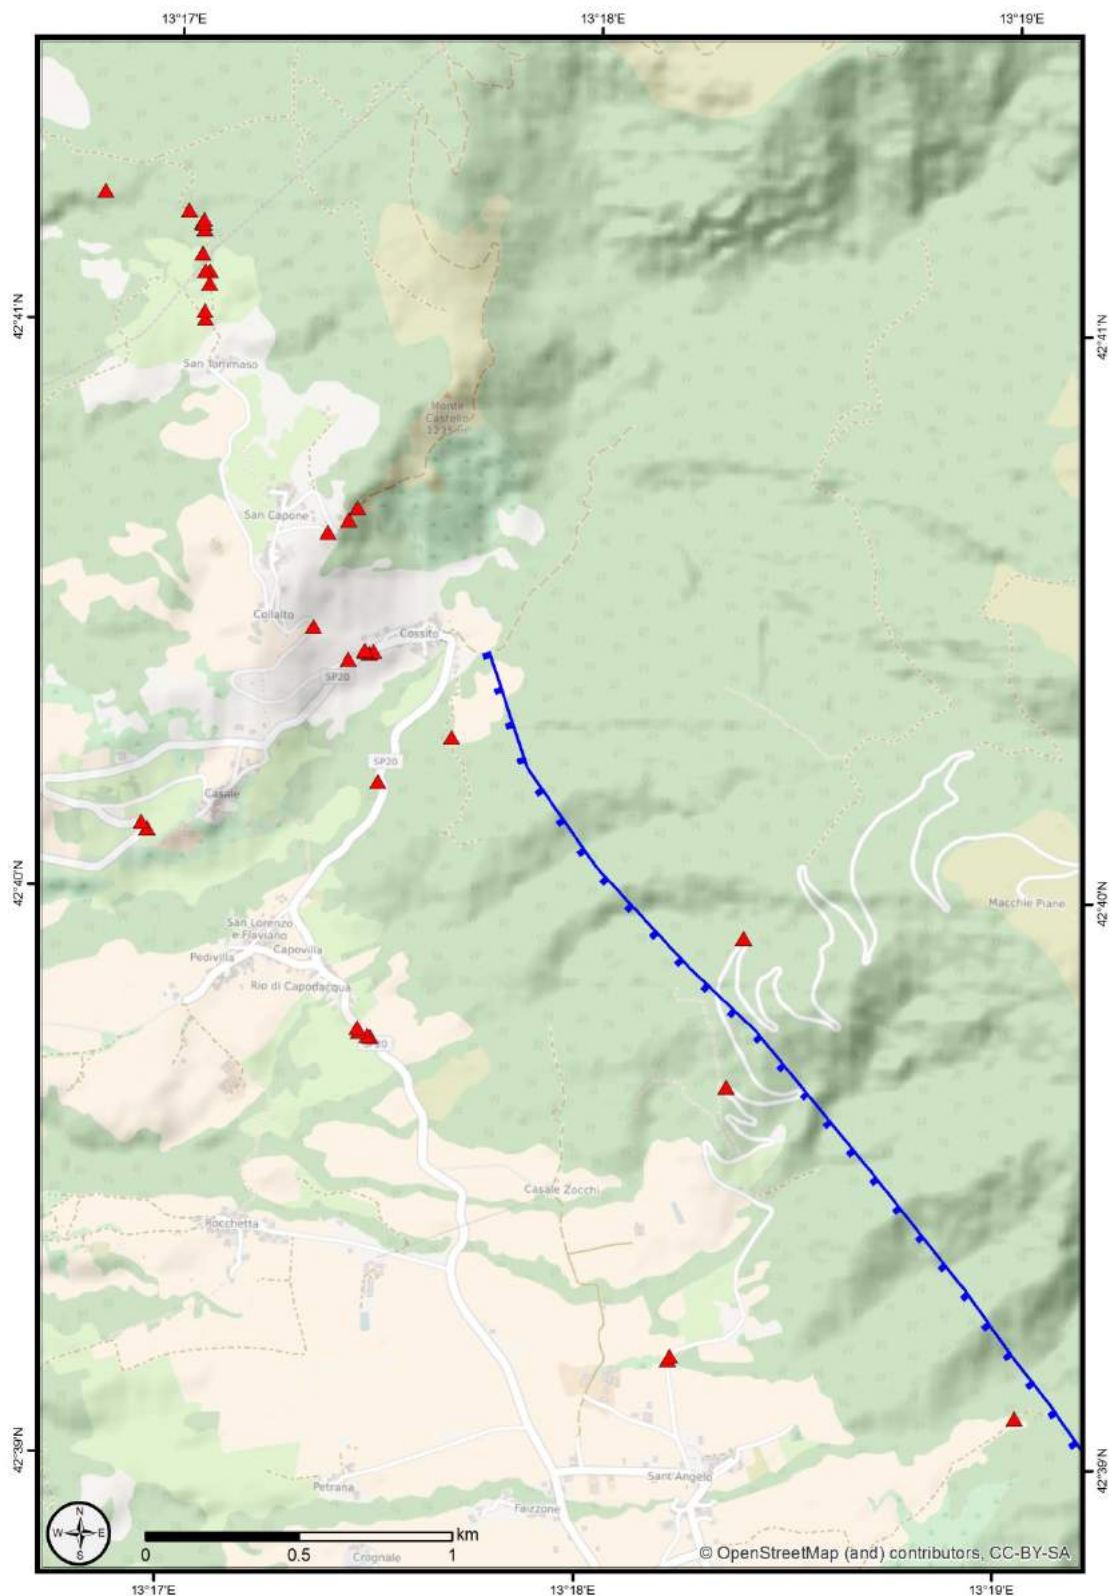
Fig. 23 – Observations points along the Laga fault (in blue as mapped in ITHACA)

In Fig. 23 the observation points close to the northern Laga fault (Amatrice fault), that is part of the seismogenic source, according to InSAR data and distribution of aftershocks are mapped. Our survey along the Amatrice fault has not detected unambiguous evidence of surface faulting to

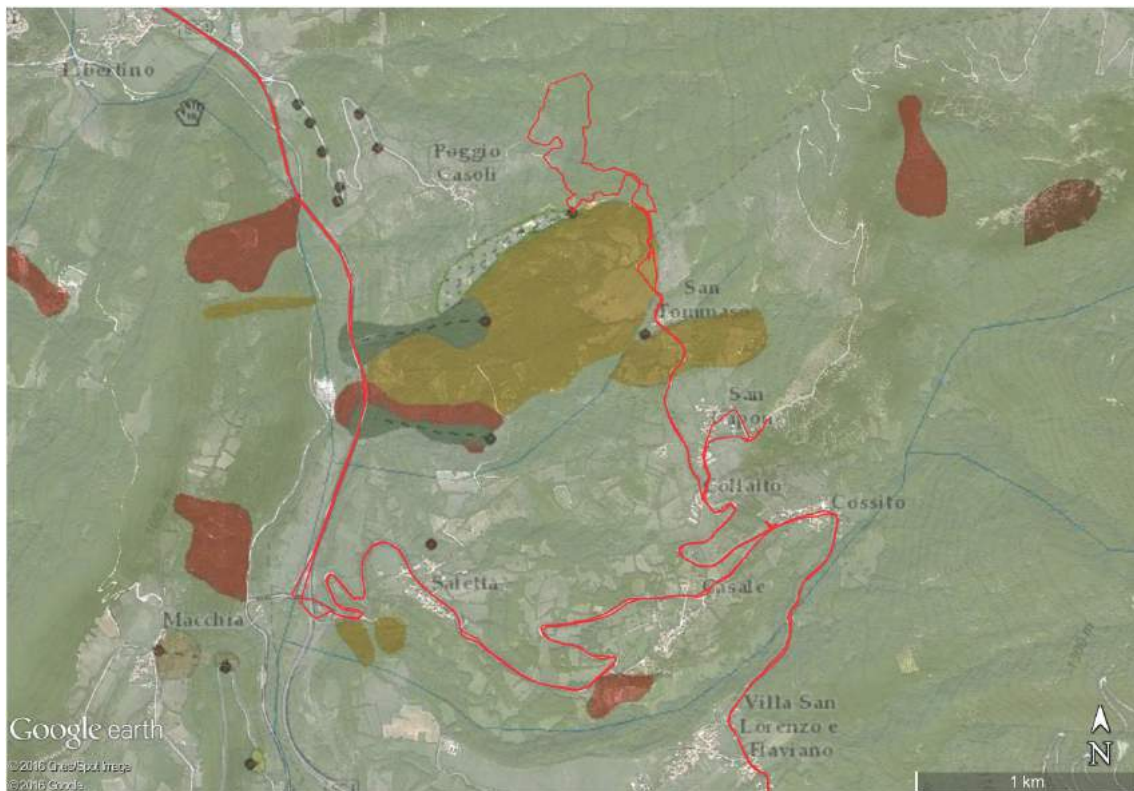
The field surveys conducted in the area between the villages of Cossito and San Tommaso (Fig. 24) have found several breaks of the ground surface observed in the meadows and along the wide trails crossing the woods, which follow the slope trend and are concentrated within an area affected by diffuse slope instability (Fig. 25).

Fig. 24 - Instability phenomena (areas in brown and yellowish color) affecting the portion of the eastern slope of Tronto Valley between Poggio Casoli, Saletta and Villa San Lorenzo e Flaviano. Slope movements are classified according to the type of movement and activity. Source and legend in PAI - Piano di Assetto Idrogeologico and IFFI project (Inventory of Landslide Phenomena in Italy; <http://www.isprambiente.gov.it/en/projects/soil-and-territory/iffi-project/default>) databases.

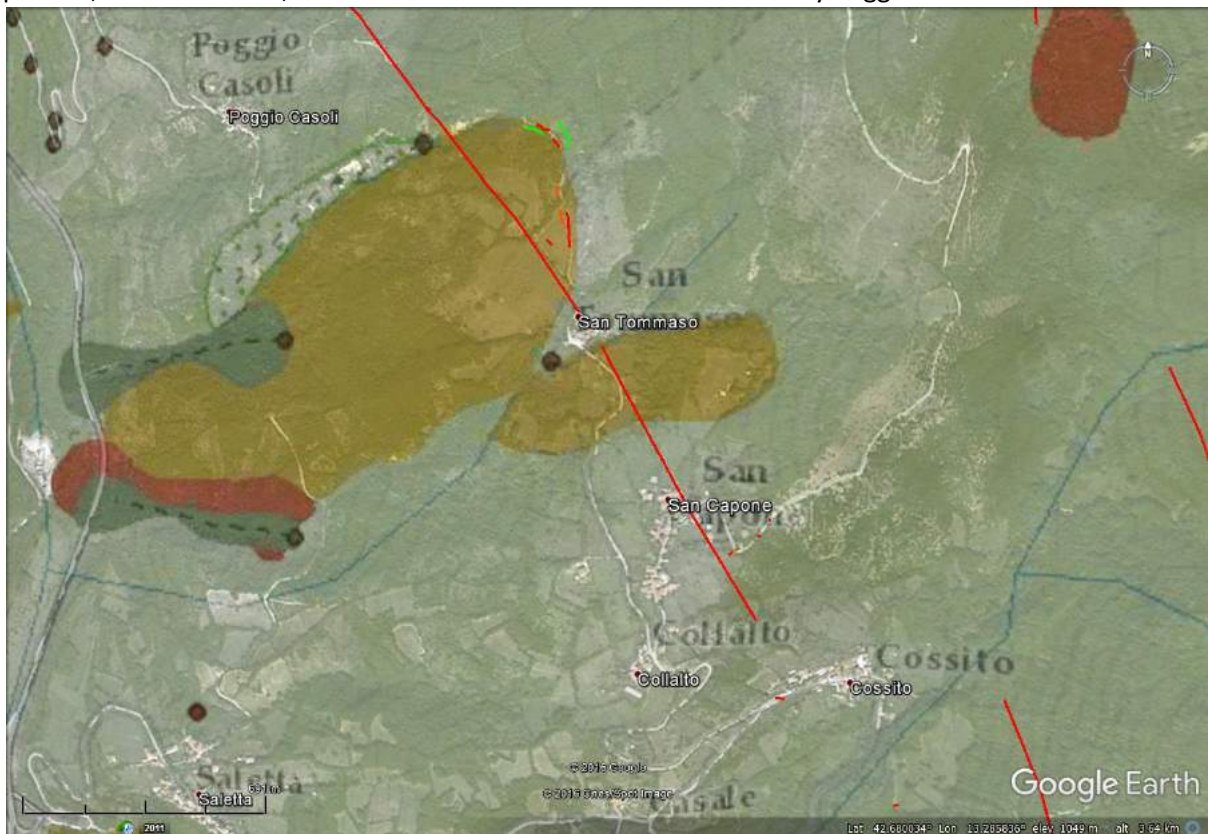
The most representative ground breaks are located along a trail/dirt road a few hundred meters to the northeast of the old cemetery. They consist of 20 m to 25 m long surface ruptures, 5 to 20 cm wide, N140 - N160 trending and west-dipping (Figs. 25 and 26). The surface ruptures appear to affect solely the colluvial deposits covering the area: no evidence of ruptured bedrock was observed during the field survey. The slope morphology is here characterized by abrupt changes, with concave and convex forms, and by a step-like slope, with sub-horizontal surfaces delimited by possible landslide scarps several meters high. In particular, two scarps 7 to 15 m high are in the surroundings of the trail (green lines in Fig. 25). Thus, the observed surface breaks are located

near the head of a large landslide, suggesting that they may be interpreted as tension cracks, sub-parallel, and connected, to the semi-crescentic crown of a seismically-triggered slide.

Fig. 25 – Small red lines correspond to the ground breaks observed in the area of San Tommaso and San Capone villages. The longer NW-SE directed red line is the northern termination of the Amatrice Fault included in the ITHACA database of capable faults. The green lines represent two morphological scarps observed around the broken trail.

Along the trail east of the small cemetery, we observed another fracture, several tens of meters long and oriented N-S (Fig. 27). Again, its location corresponds to the eastern border of a known slope movement (Fig. 25).

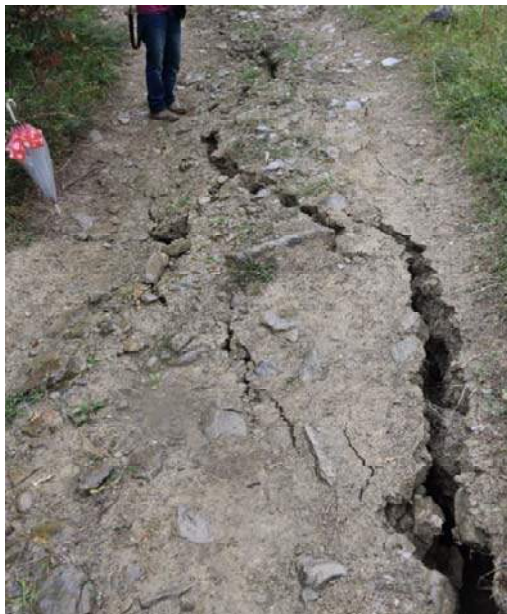
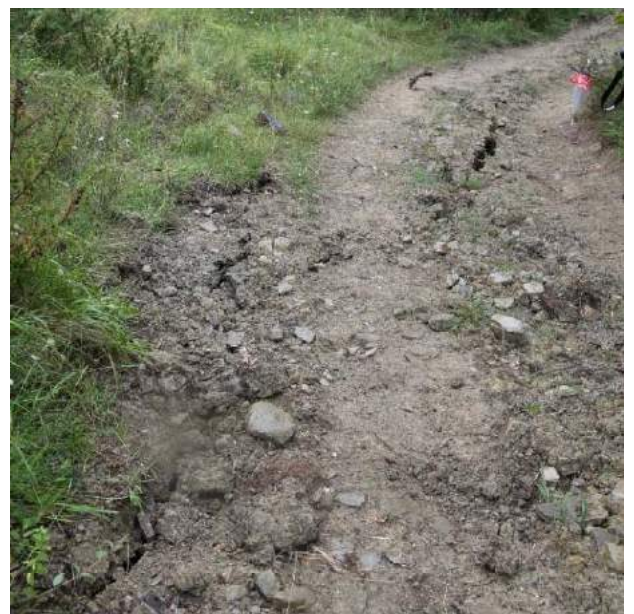
Fig. 26 – San Tommaso. Surface rupture 25 m long, 5 to 20 cm wide. Some segments of the rupture are characterized by 5 cm to 10 cm vertical offset. Left: view to the north; Right: view to the south

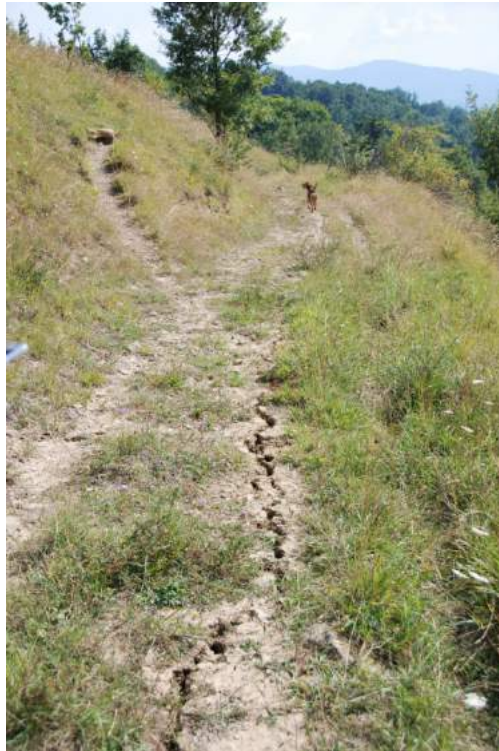
Fig. 27 – Fracture N-S oriented, about 50 m long, along the trail east of the small cemetery.

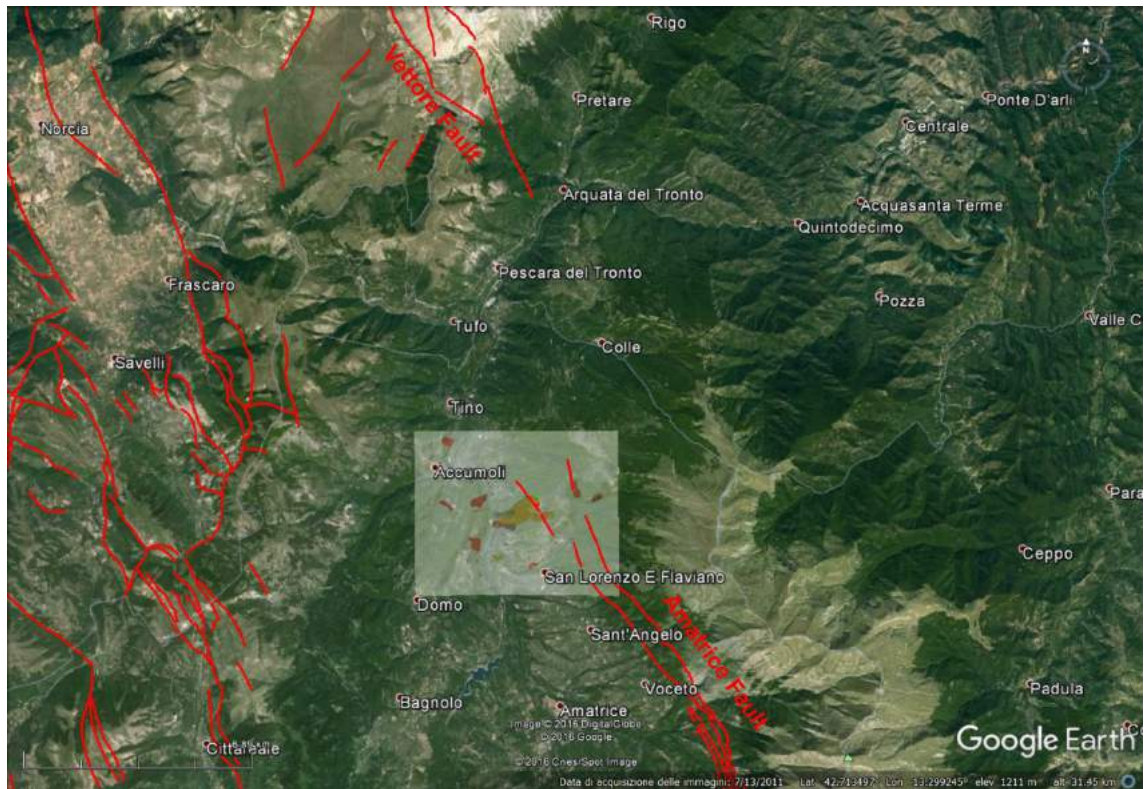
Fig. 28 – Capable faults (in red) from ITHACA catalogue showing that the investigated area is located in the projected northern prolongation of the Amatrice fault toward the Monte Vettore fault.
